Sewerage & Water Board OF NEW ORLEANS

Re: Sewerage and Water Board of New Orleans (SWBNO)
LSP Incident No. 18-03596
National Response Center Incident No. 1220212

**SUMMARY OF DIESEL SPILL
FLORIDA AVENUE CANAL
AUGUST 1-9, 2018
FINAL REPORT**

E.A.D. INVESTIGATOR'S REPORT

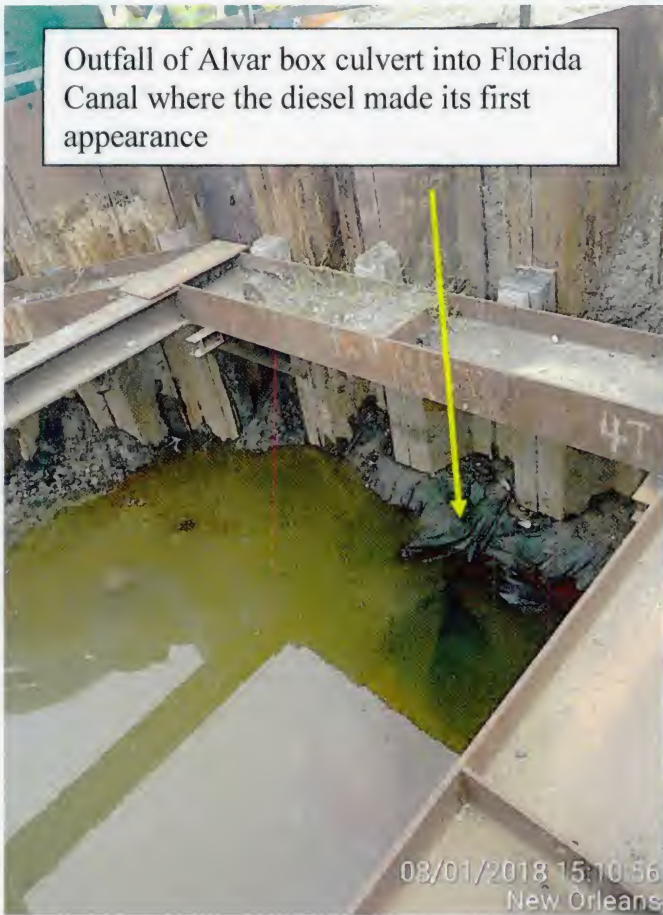
Outfall of Alvar box culvert into Florida Canal where the diesel made its first appearance

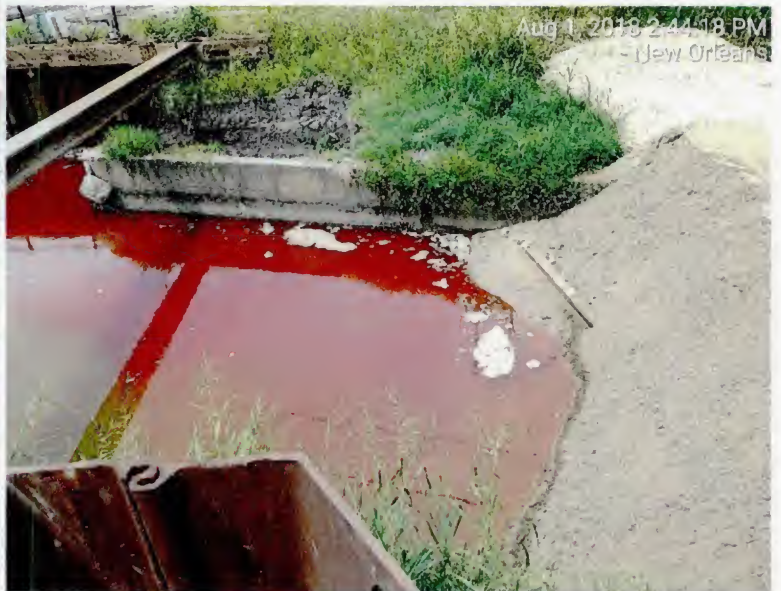
Diesel pooling at Boh Bros. sand dam

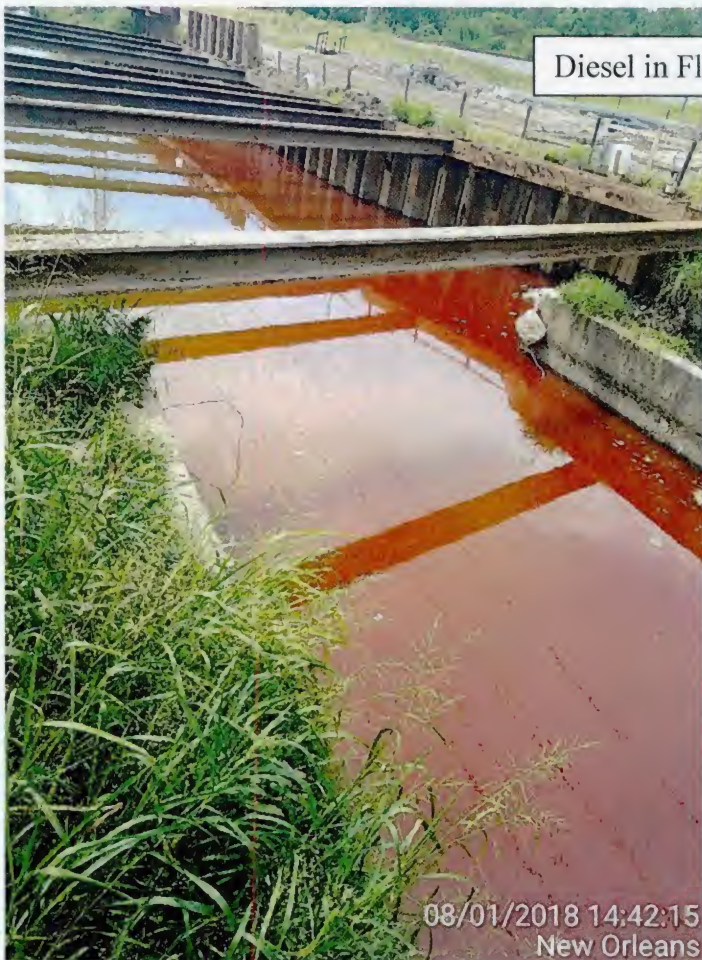
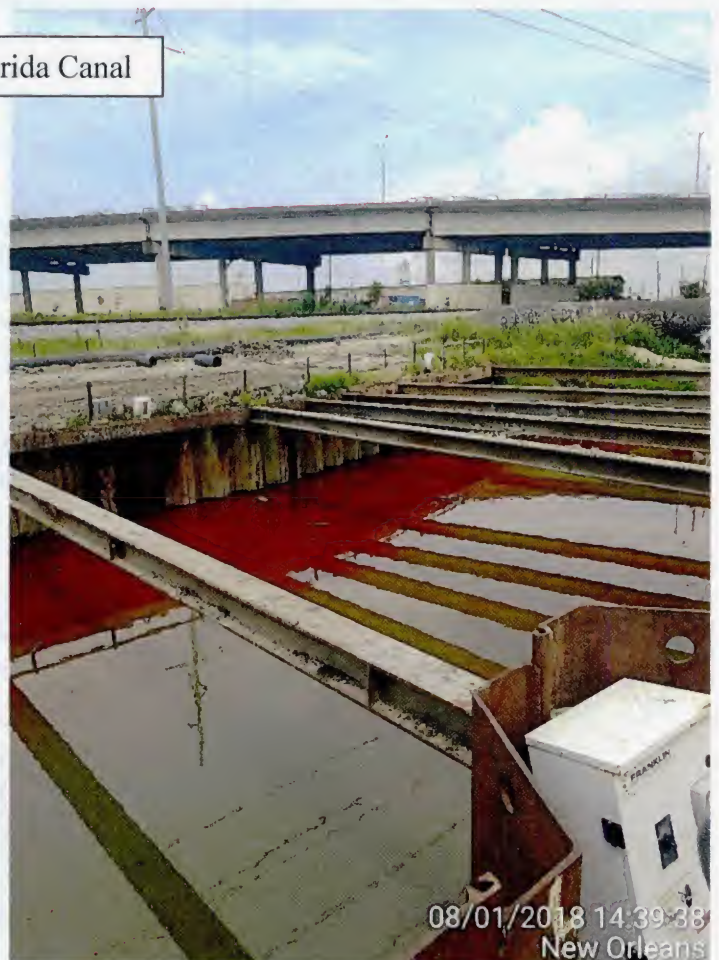
Diesel in Florida Canal

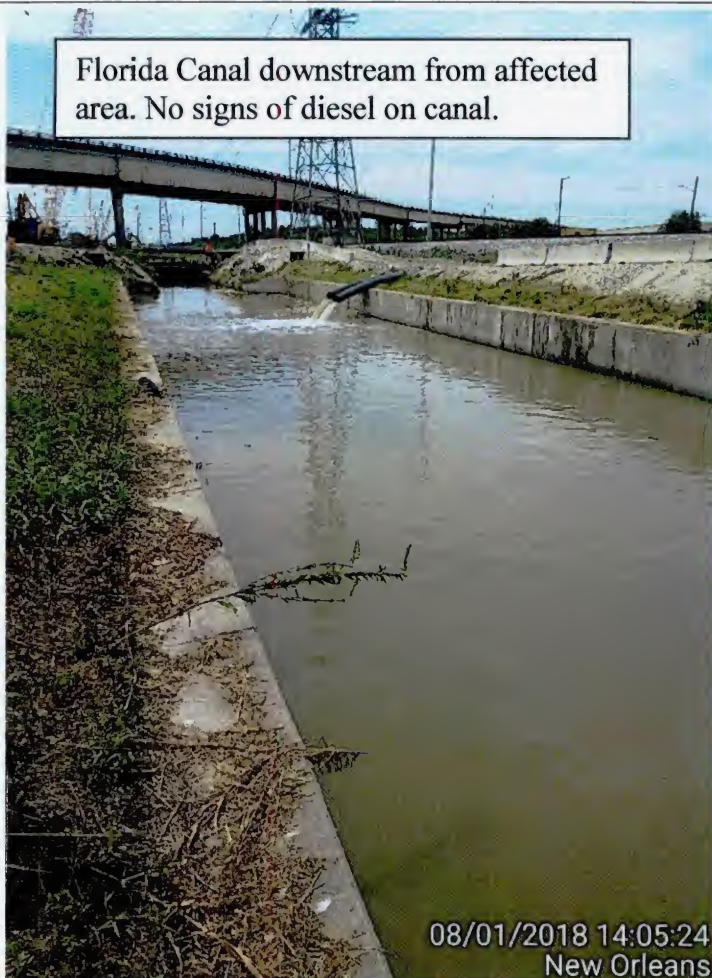
Florida Canal downstream from affected area. No signs of diesel on canal.

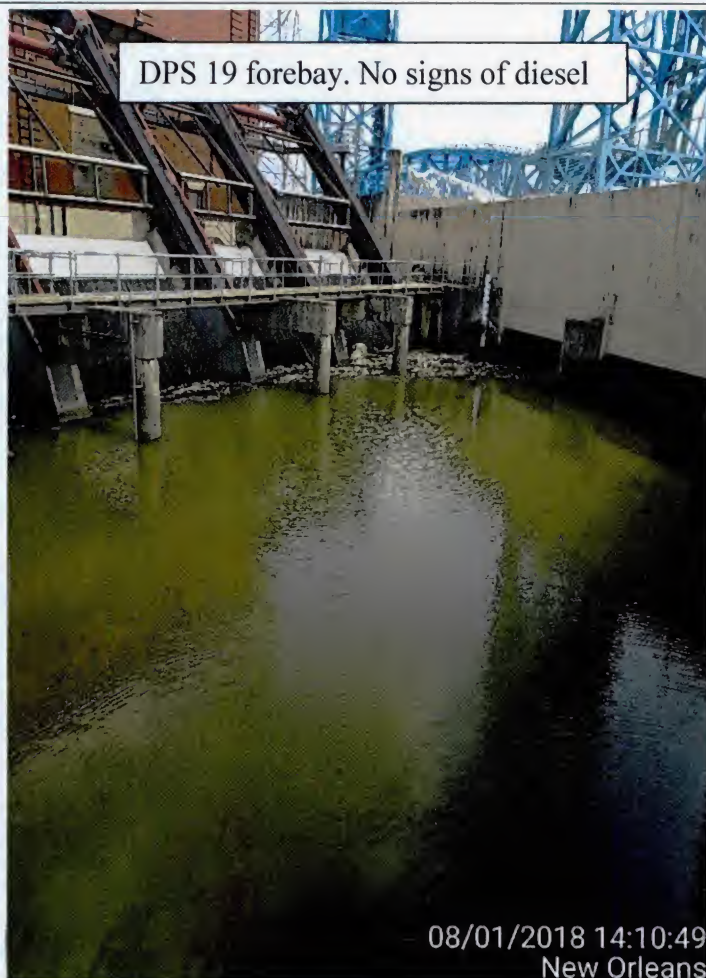
DPS 19 forebay. No signs of diesel

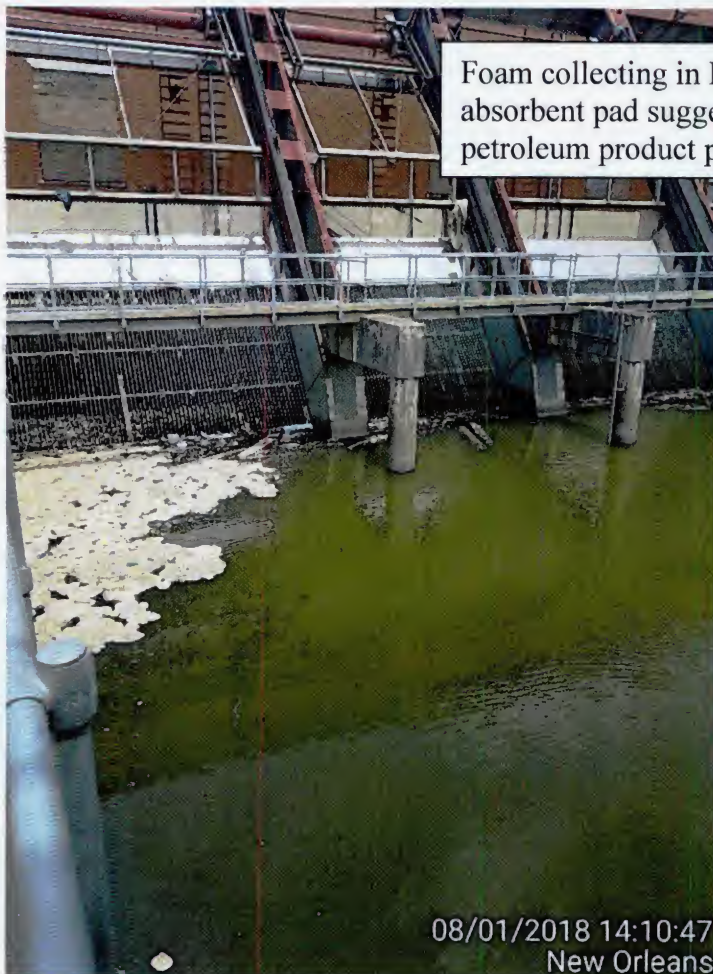
Foam collecting in DPS 19 forebay, oil absorbent pad suggested there was no petroleum product present

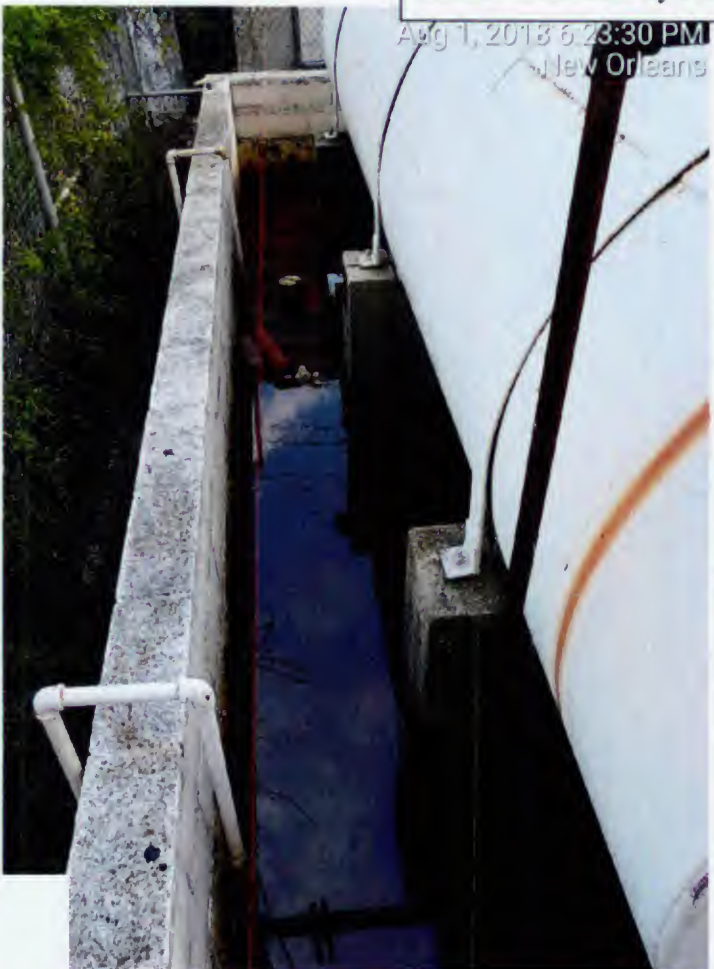
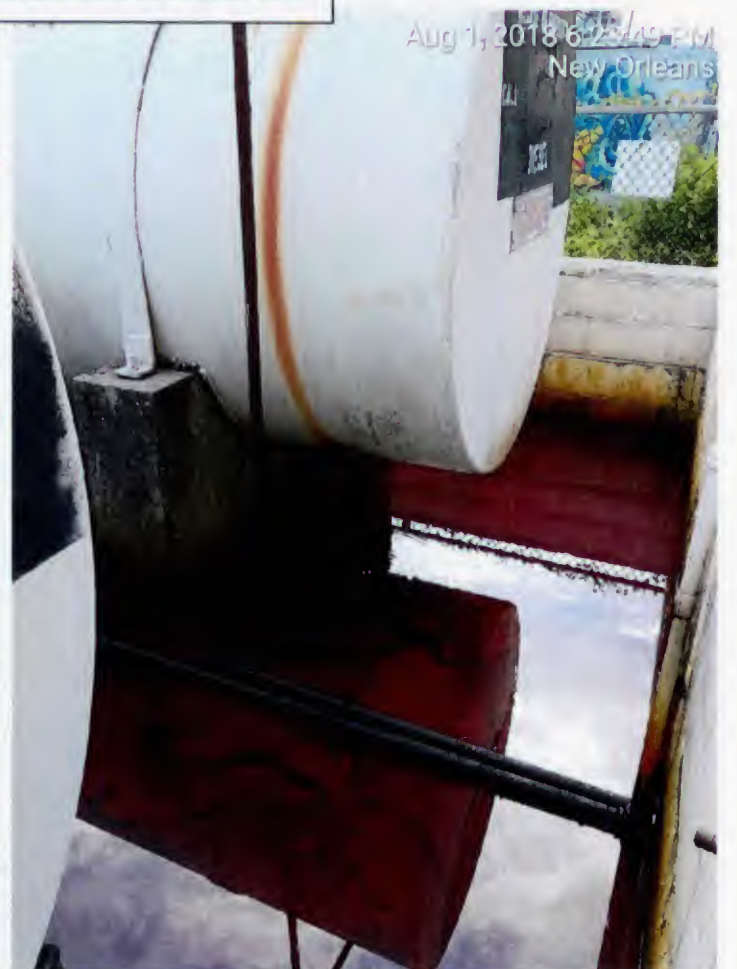
Trespassers scrapping material from the abandoned Naval Base on Poland Avenue removed brass plugs from the bottom of two roughly 2000 gallon storage tanks which emptied their contents into non-watertight secondary containment, then into the drainage system and eventually to the Florida Canal and Drainage Pump Station 19. None of the product was discharged past the drainage pump station.

Diesel in secondary containment at source site

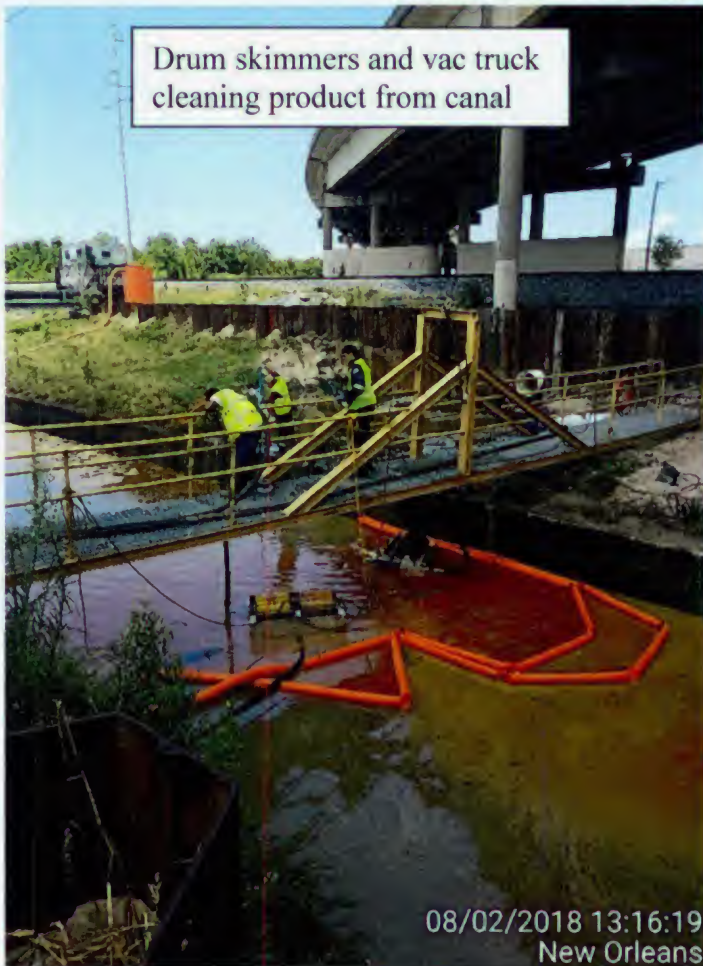
Drum skimmers and vac truck cleaning product from canal

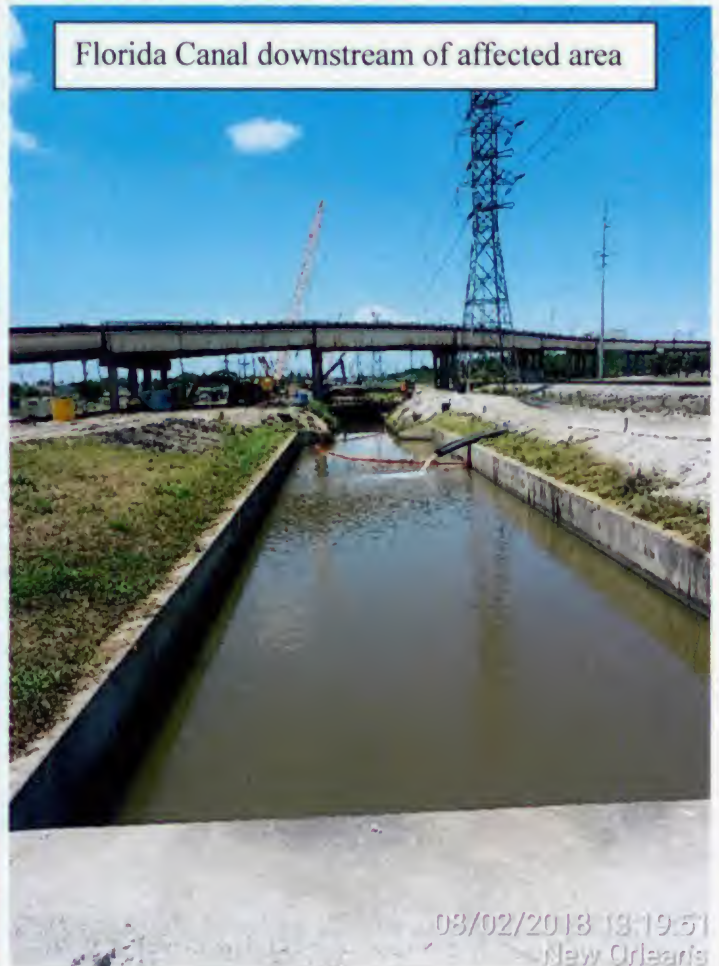
Florida Canal downstream of affected area

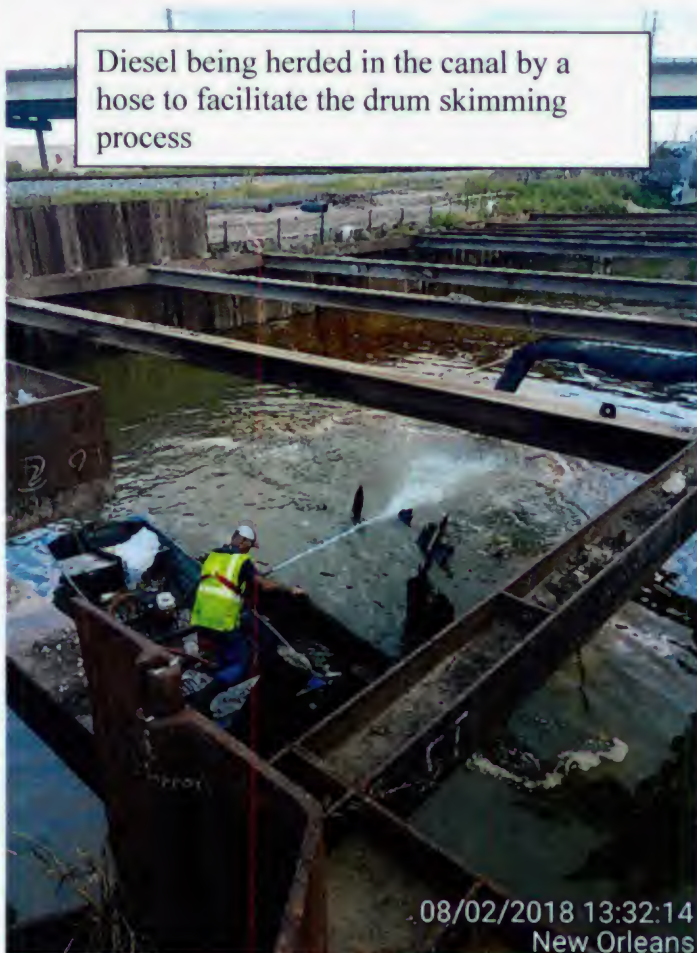
Diesel being herded in the canal by a hose to facilitate the drum skimming process

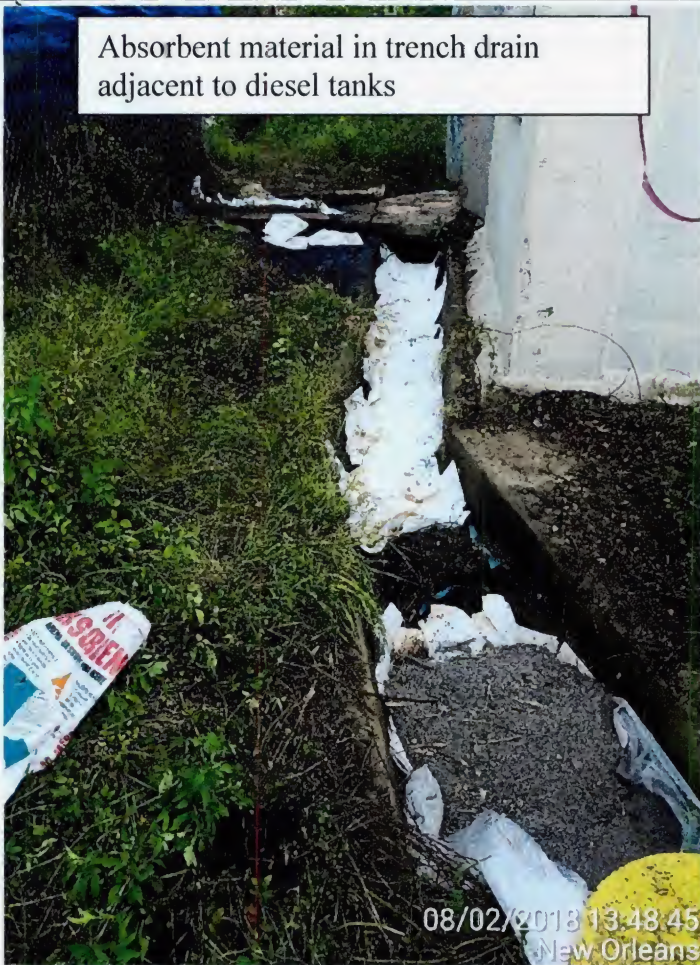
Absorbent material in trench drain adjacent to diesel tanks

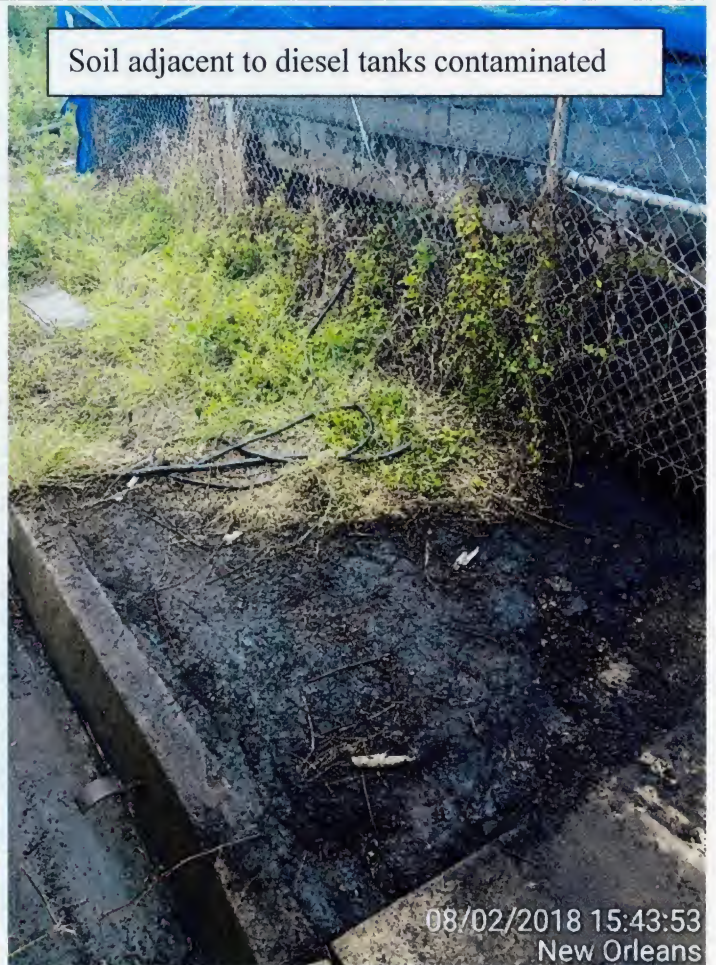
11. Discharge of diesel entered storm drainage and sewer systems. Diesel has been found on the ground next to the containment area. These areas have been cleaned.

Soil adjacent to diesel tanks contaminated

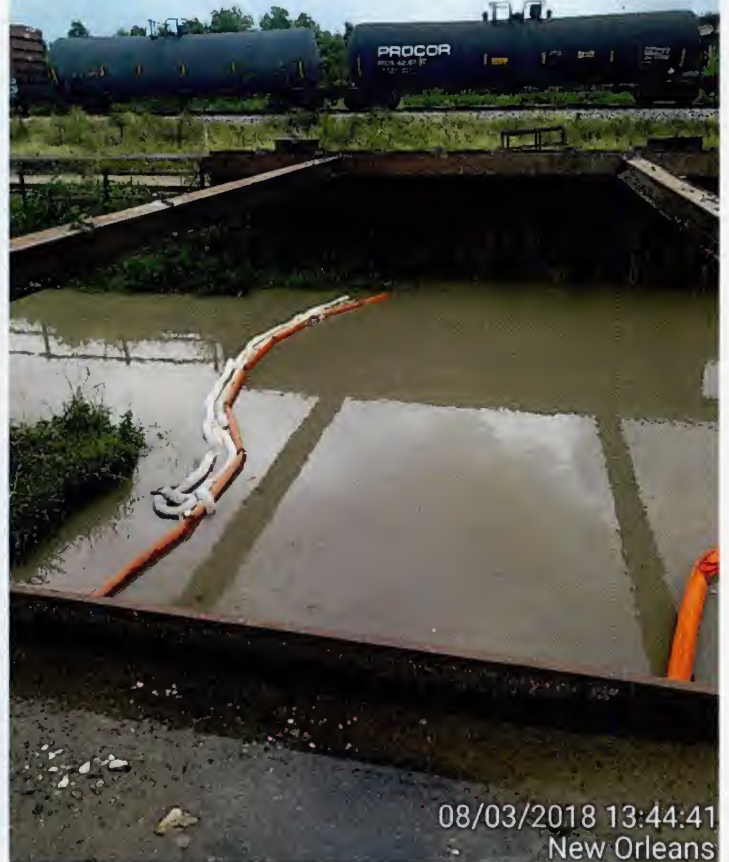
Soft and hard boom in Florida Canal

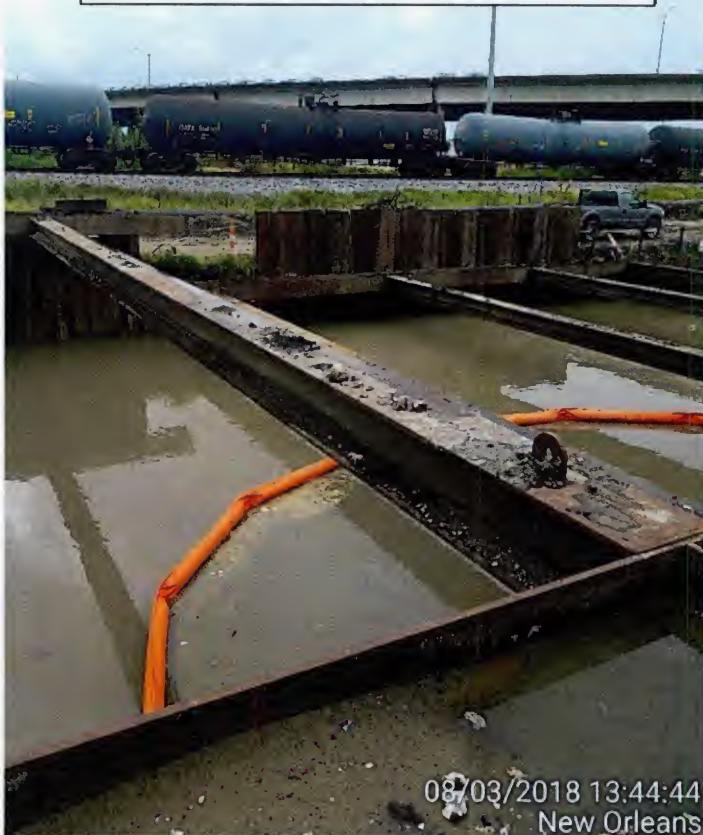
Boom capturing inflow from Alvar box culvert in Florida Canal

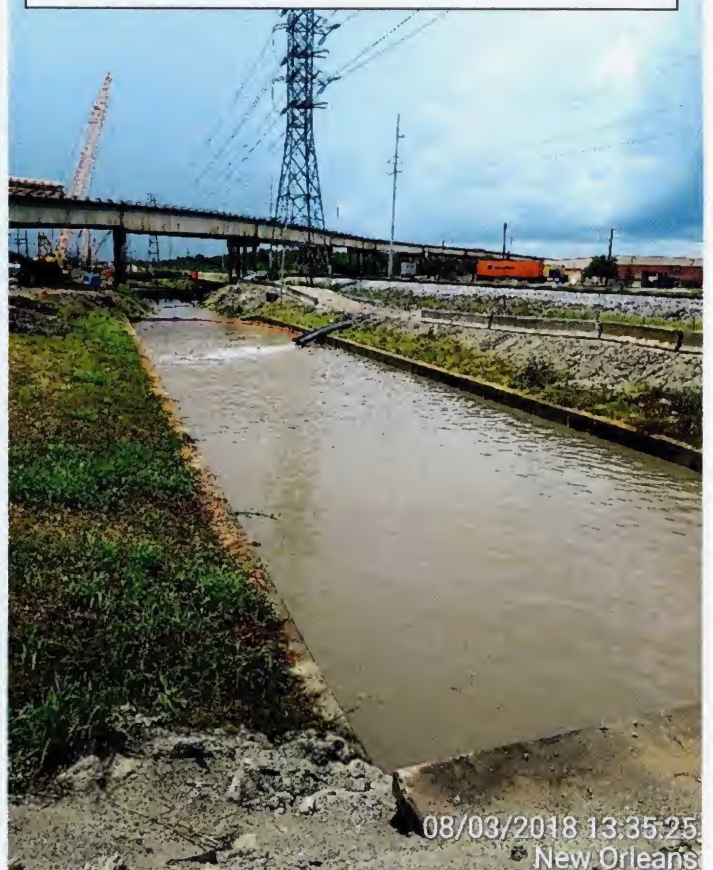
Florida Canal downstream from affected area

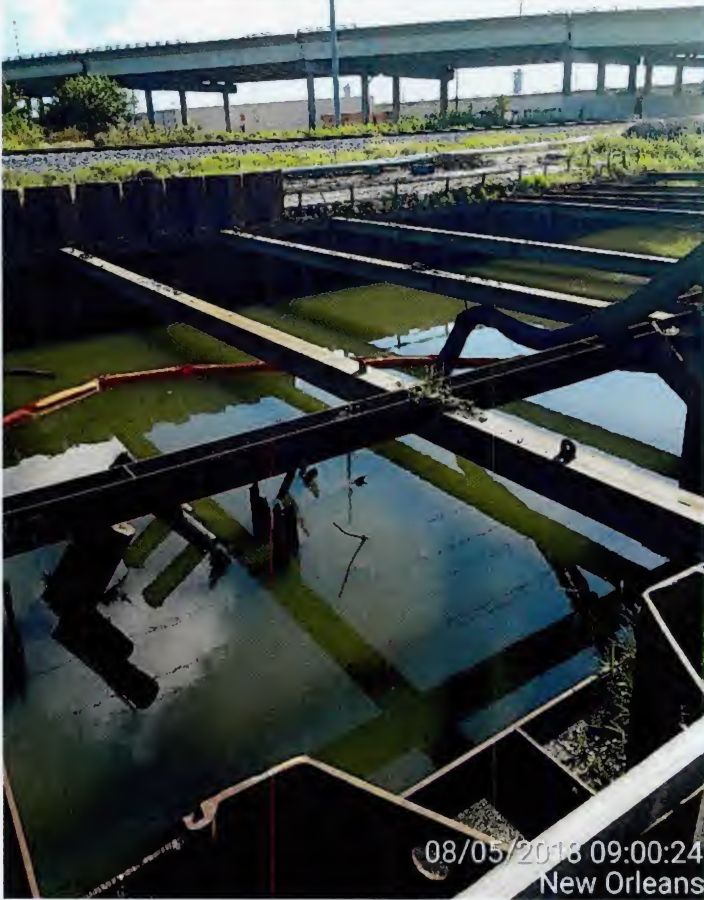
Boom at Alvar box culvert outfall intact

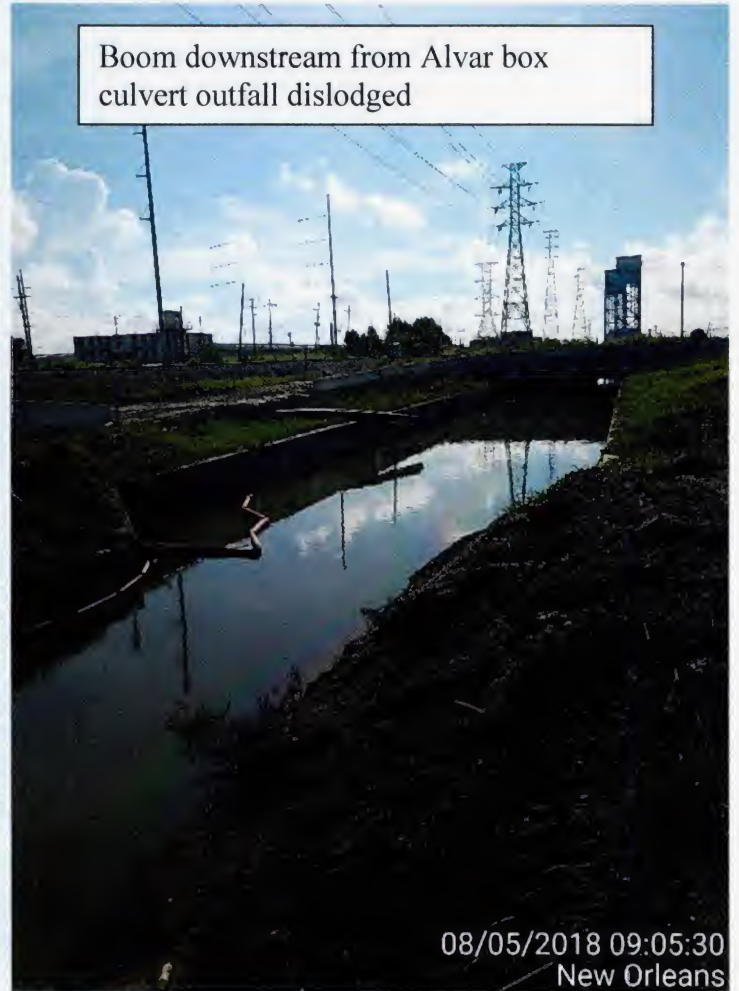
Boom downstream from Alvar box culvert outfall dislodged

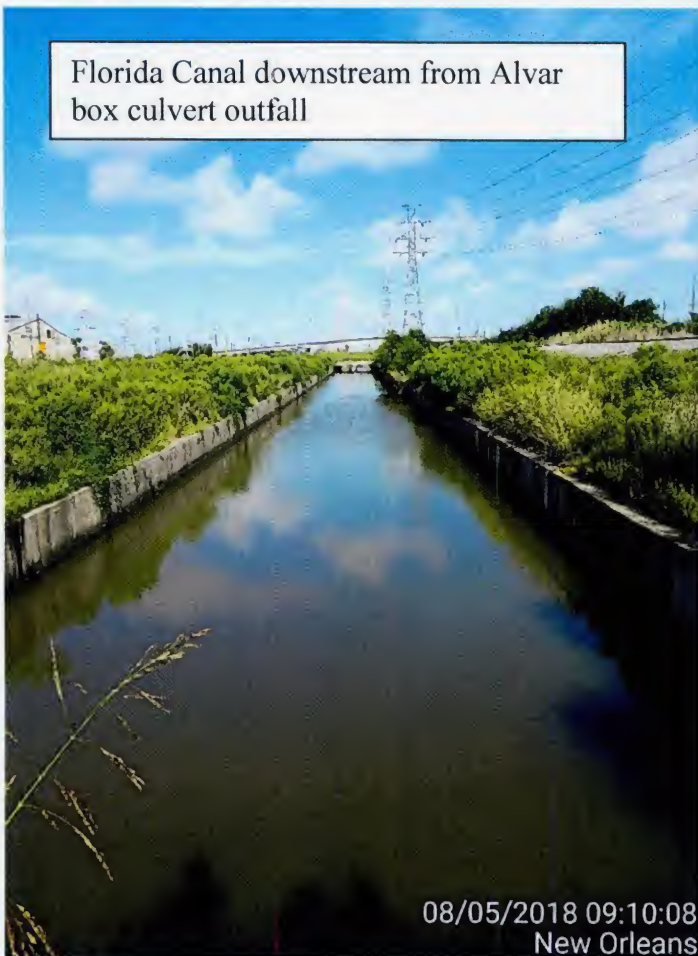
Florida Canal downstream from Alvar box culvert outfall

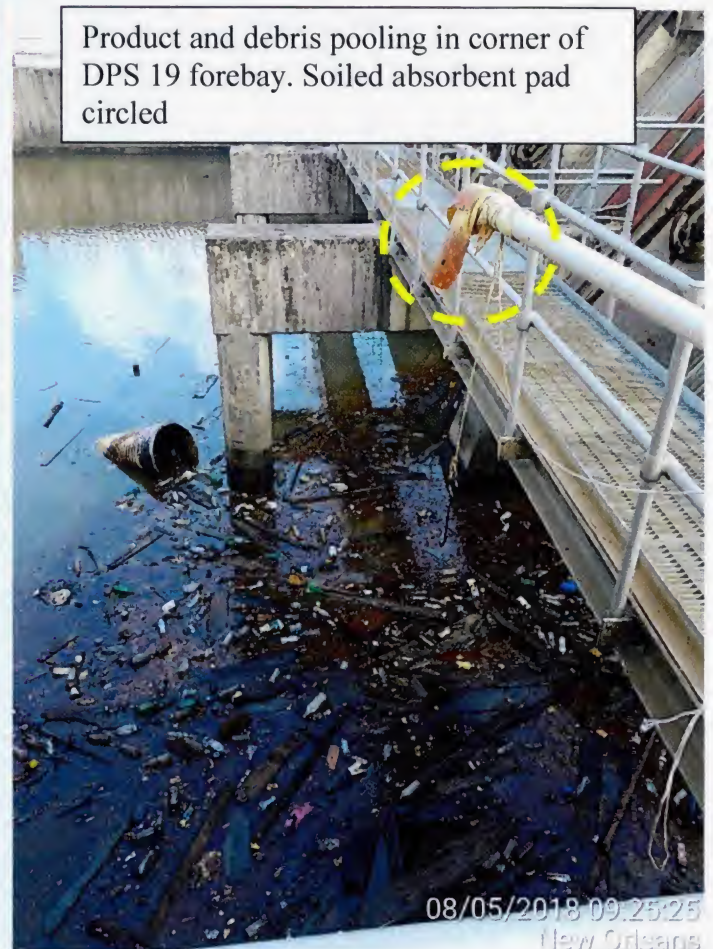
On Sunday, August 5, 2018, at 07:45 HRS, Scott Finney of SWBNO EAD received a call from Drainage Operations that there was product in the forebay of DPS 19. Eddy Schneider dispatched to the site and confirmed that there was product in the forebay and called OMI out for cleanup. OMI cleaned the product out of the canal with absorbent material and a vac truck. The crew utilized the trash rakes and screens at the station to remove large pieces of wood and other debris to facilitate the cleanup process. Removing product from behind the trash screens posed the largest challenge. Three ducklings and two turtles were removed from the forebay and were picked up by LA Department of Wildlife and Fisheries at the end of the day.

Product and debris pooling in corner of DPS 19 forebay. Soiled absorbent pad circled
